AFML-TR-76-50

Plastic
DEVELOPMENT OF LARGE SCALE EXTRUSIONS

AMOCO CHEMICALS CORPORATION
SEYMOUR INDIANA

FINAL REPORT

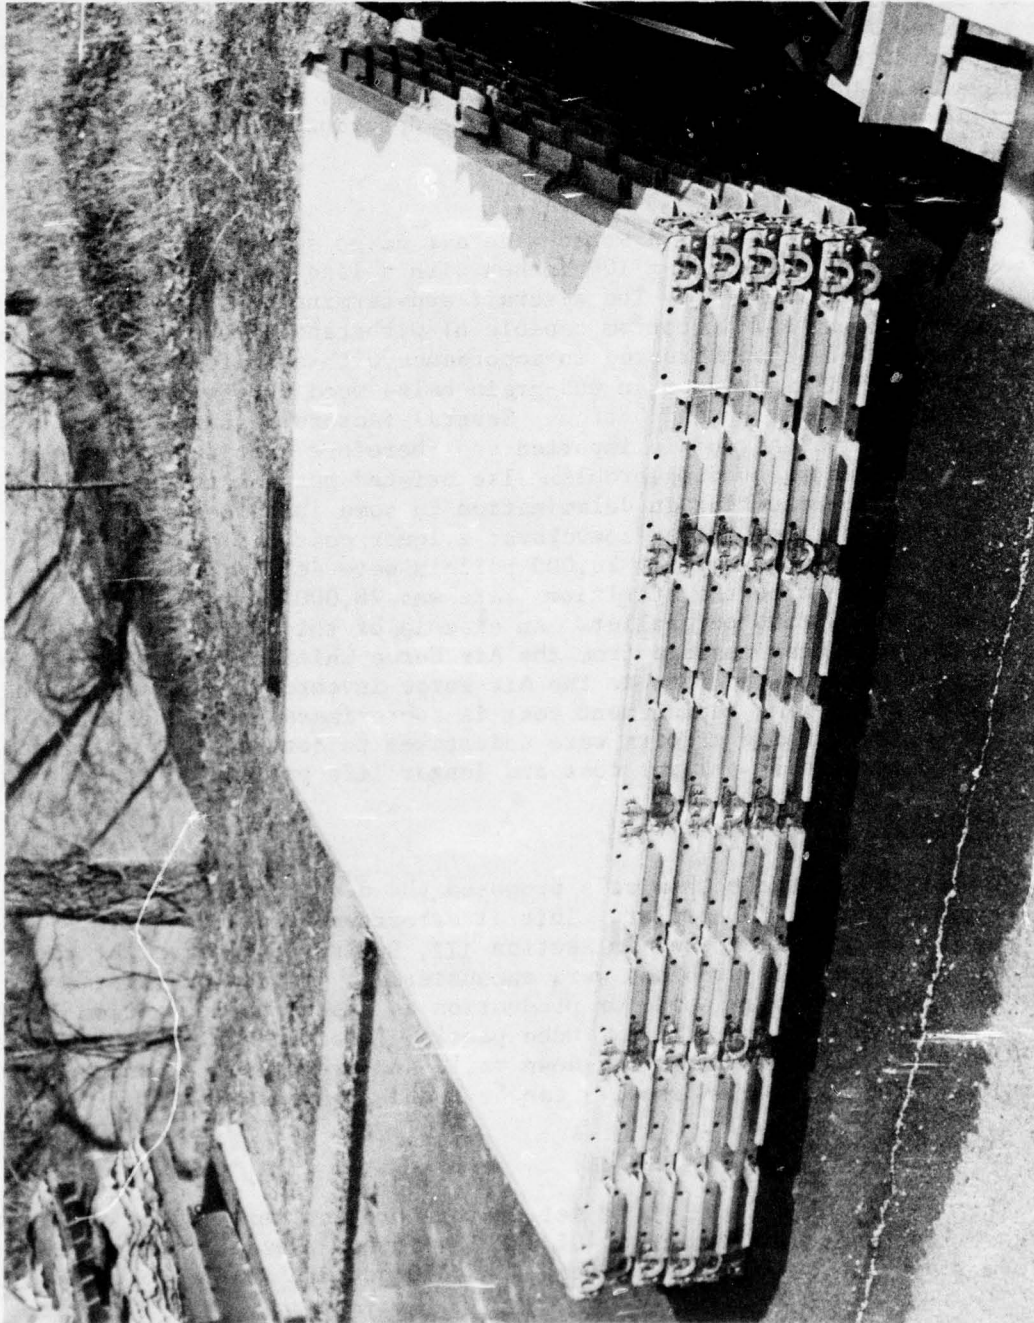
Figure 1 - Ten thousand pound AF Pallet

The Air Force operates a world-wide air cargo system basically revolving around a pallet 88 x 108 inches with a load capacity of 10,000 pounds as shown in Figure 1. The aircraft and terminal systems use roller conveyors requiring a flat bottom capable of withstanding the roller loads. The present pallet is constructed in accordance with specification MIL-P-27443E(USAF) and is made from an end-grain balsa wood core with an aluminum facing bonded on both top and bottom. Several factors resulted in the start of this program; balsa wood is imported and therefore continuing supplies are not guaranteed; a bonding problem also existed between the balsa wood and aluminum skin resulting in delamination in some instances from cold working the pallet over roller conveyors; a lower cost pallet. For example, in FY 69 approximately 26,000 pallets were delivered to the Air Force, at the same time the attrition rate was 28,000 units with an average cost of \$302.00 per pallet. An example of this high loss rate is found in the following message from the Air Force Chief of Staff, 13 Dec 68: "Loss of 463L pallets and nets to the Air Force inventory continues at an unacceptable rate. The replacement cost is approximately one million dollars a month." While efforts were undertaken to control losses, a need also existed to develop a lower cost and longer life pallet.

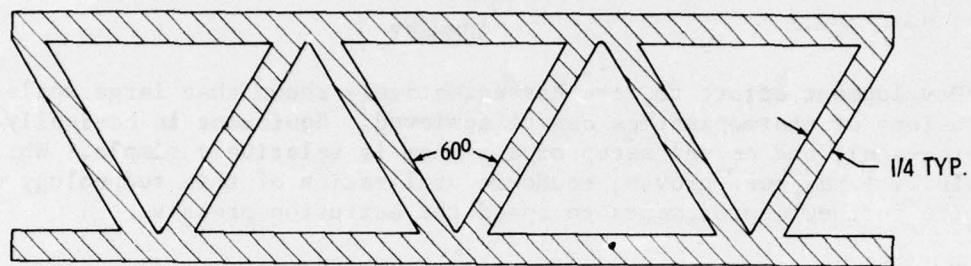
FIGURE 2 WARREN TRUSS DESIGN

The method used was similar to injection molding a part, but on a very large scale. A mold was fabricated to make a section 11-inch wide and 96-inch long using a Warren truss design as shown in Figure 2. The process consisted of forcing the molten plastic into a heated mold. An extruder was utilized to heat the plastic above its melting point and provide the necessary force to cause it to flow into the mold as shown in Figure 3. After the mold was filled, the process was shut down until the mold cooled, was disassembled, finished panel removed, and reassembled.

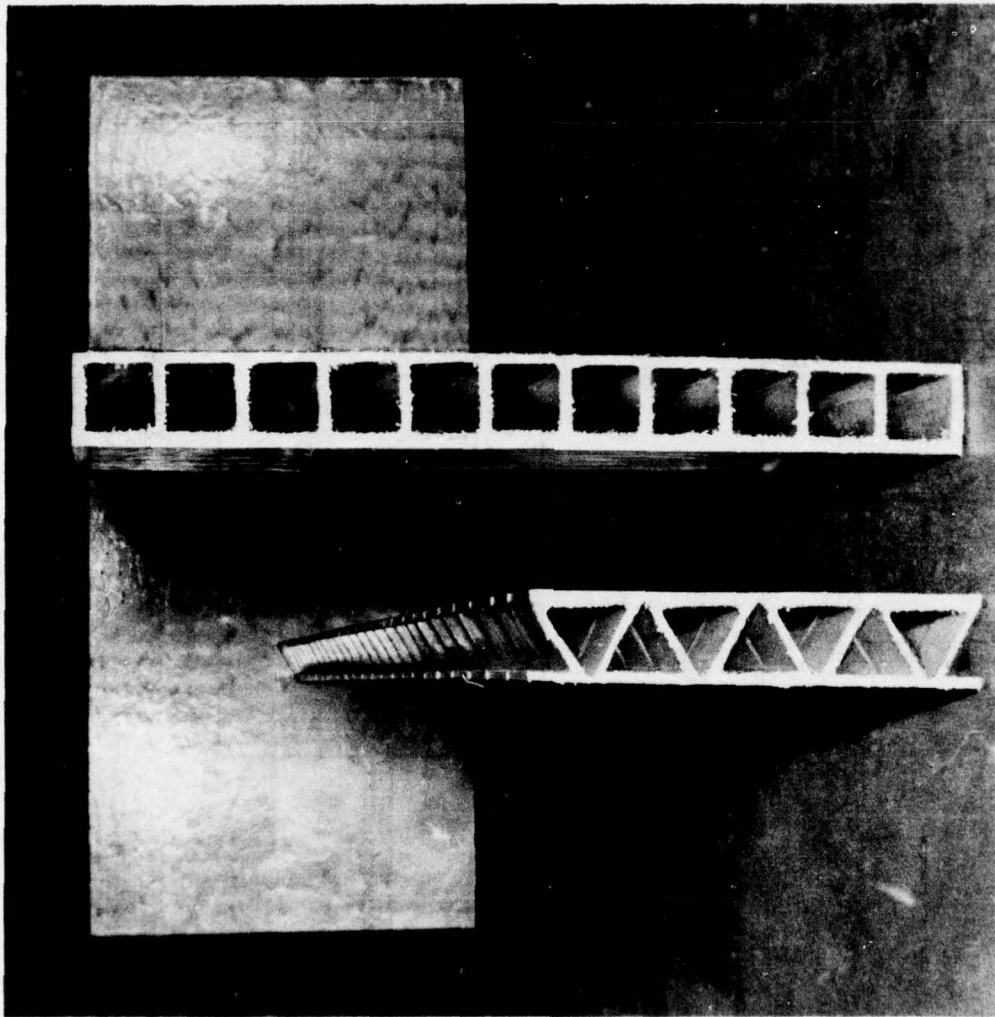
Figure 5 - Twenty-Two Inch Wide Extrusion

To determine the feasibility of this approach, a 22-inch wide (Figure 5) extrusion was fabricated with one accumulator between the die and extruder. Trial runs resulted in two changes, both in die configuration. Both were related to cooling the material. The die was originally designed with a thermal barrier; this hot/cool zone produced a weld line as shown in Figure 6, which was subsequently found to be a weak point. Removing the thermal barrier and lengthening the die from 16 to 18 inches, resulted in a gradual temperature gradient and elimination of weld lines.

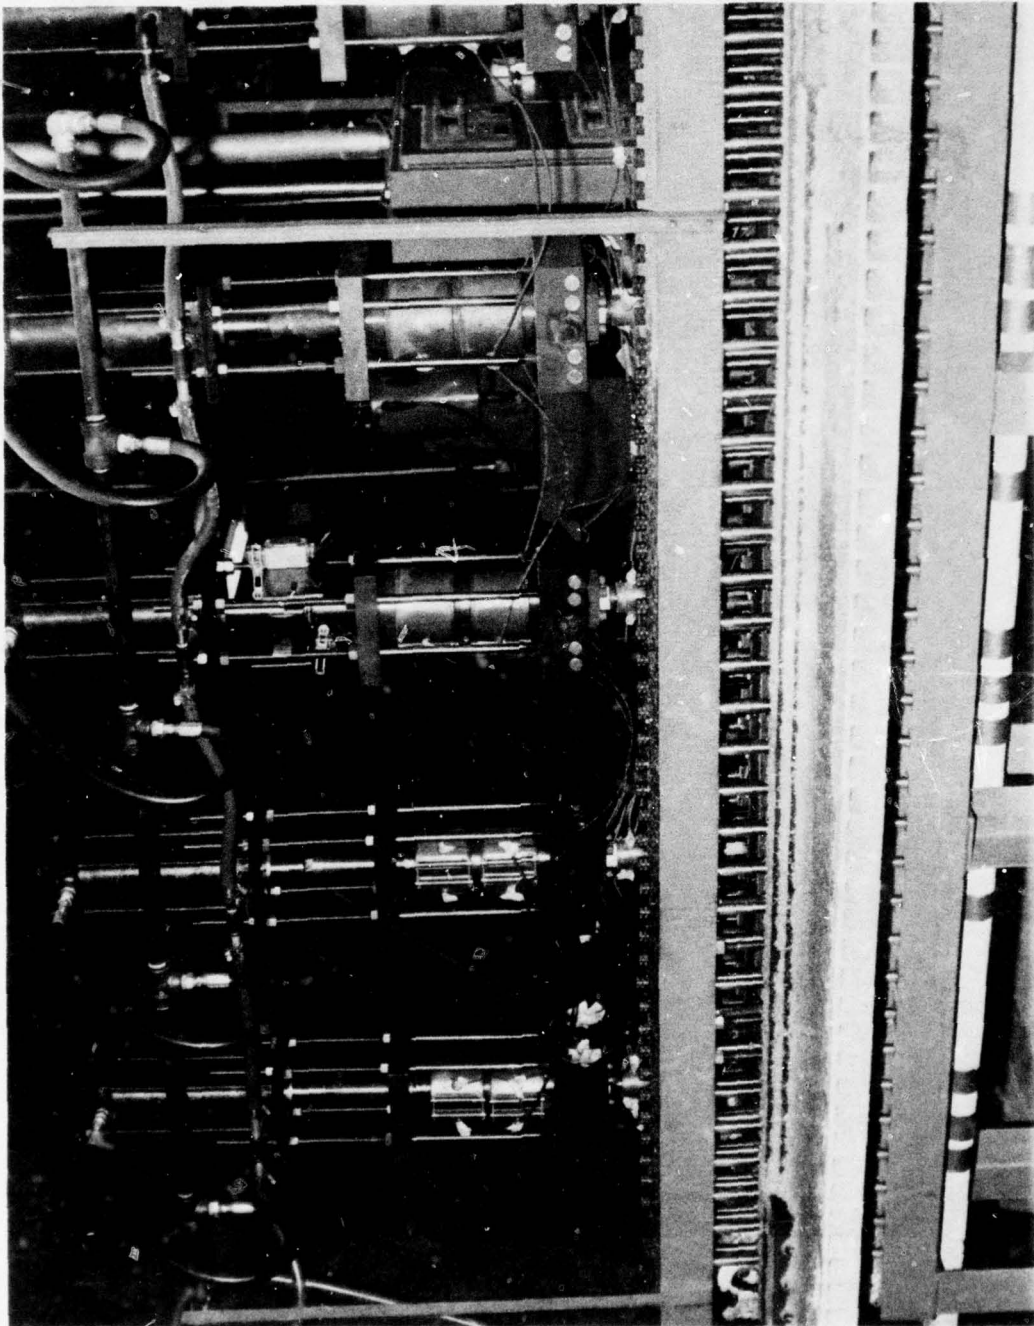
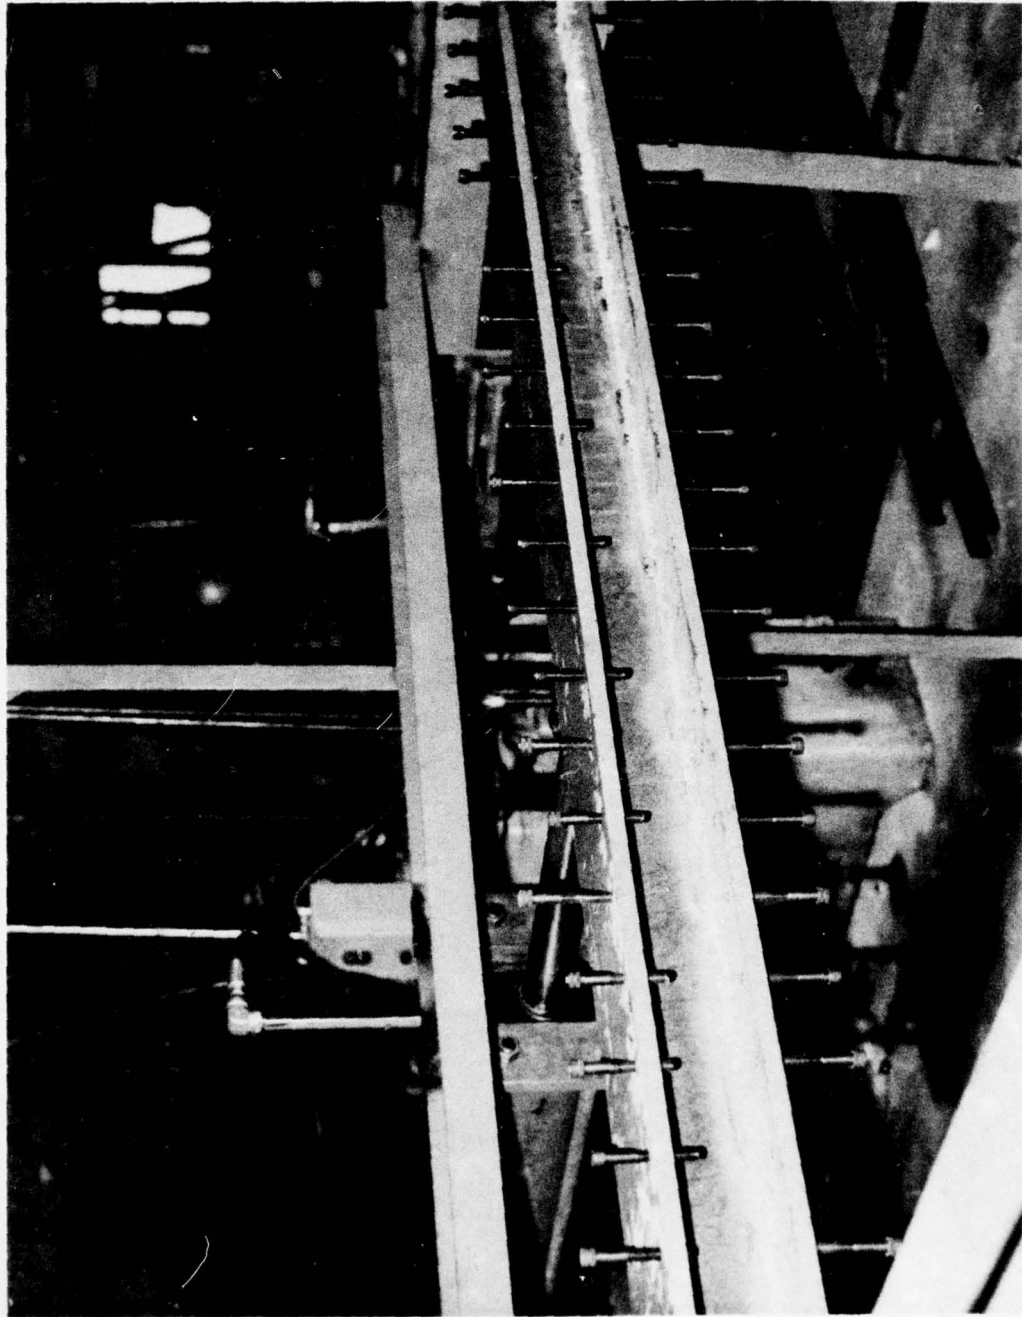
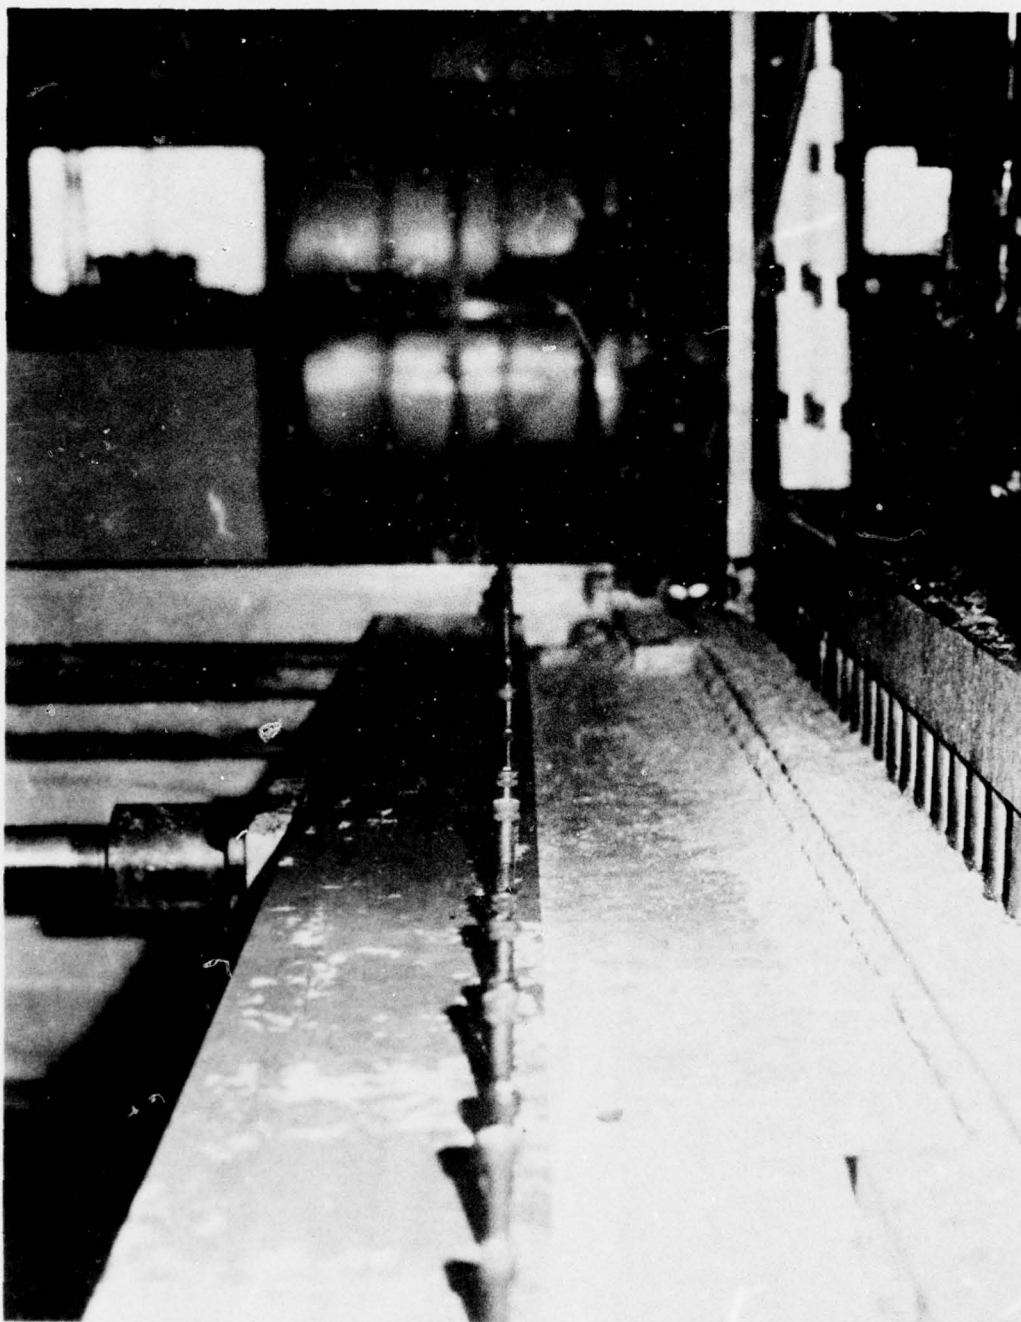
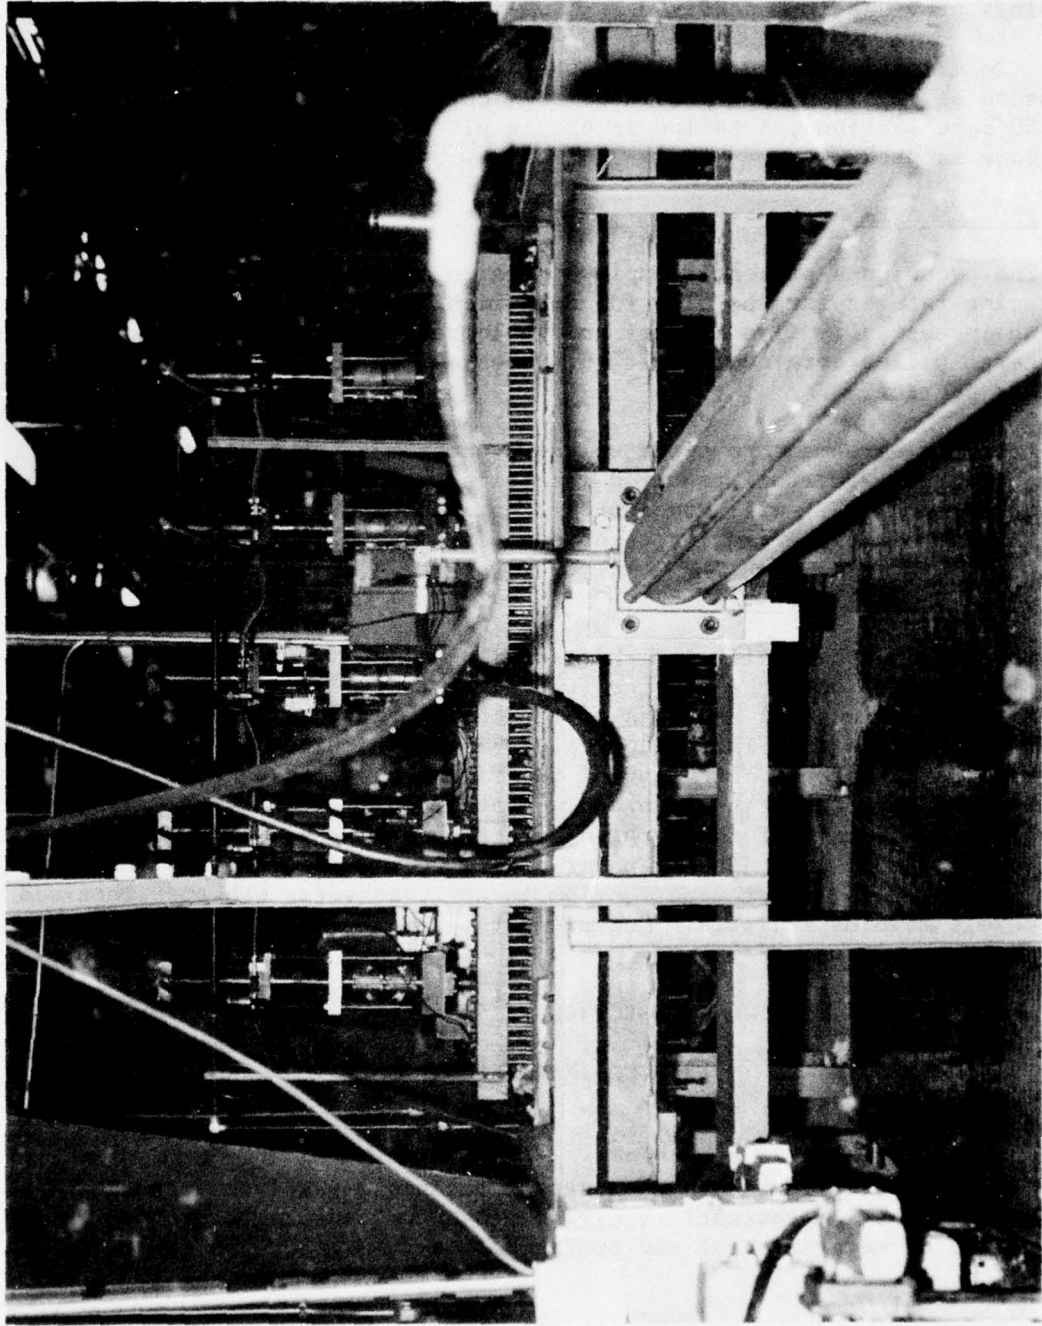
The push/pull unit was clamped to the extruded part (Figures 12-15) by screwing bolts into the polymer panel. The hydraulic equipment used was a 6-inch bore cylinder with a travel of 8 feet. The limit switch on the center accumulator was also used to control the push/pull cycle during operation.

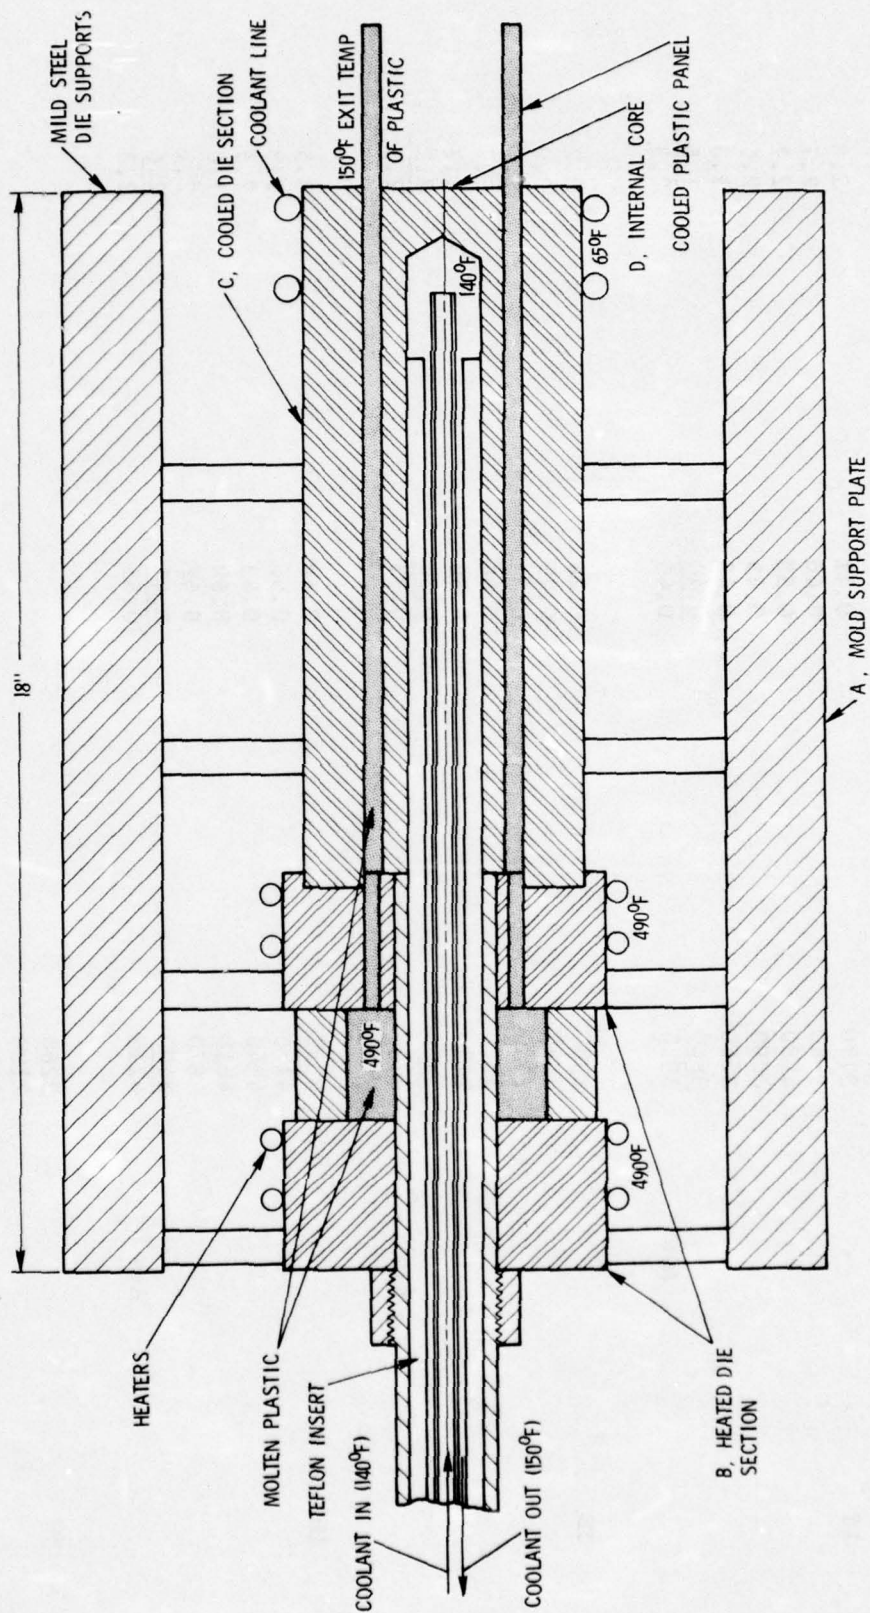
FIGURE 16 DIE CROSS SECTION

The die was based on conventional techniques with five entry points. In essence each entry area acted as a separate extruder and with the material being molten and under pressure, complete fusion was possible at the heated rear of the die. The die cross-section is shown in Figure 16 with detail drawings provided in Appendix E.

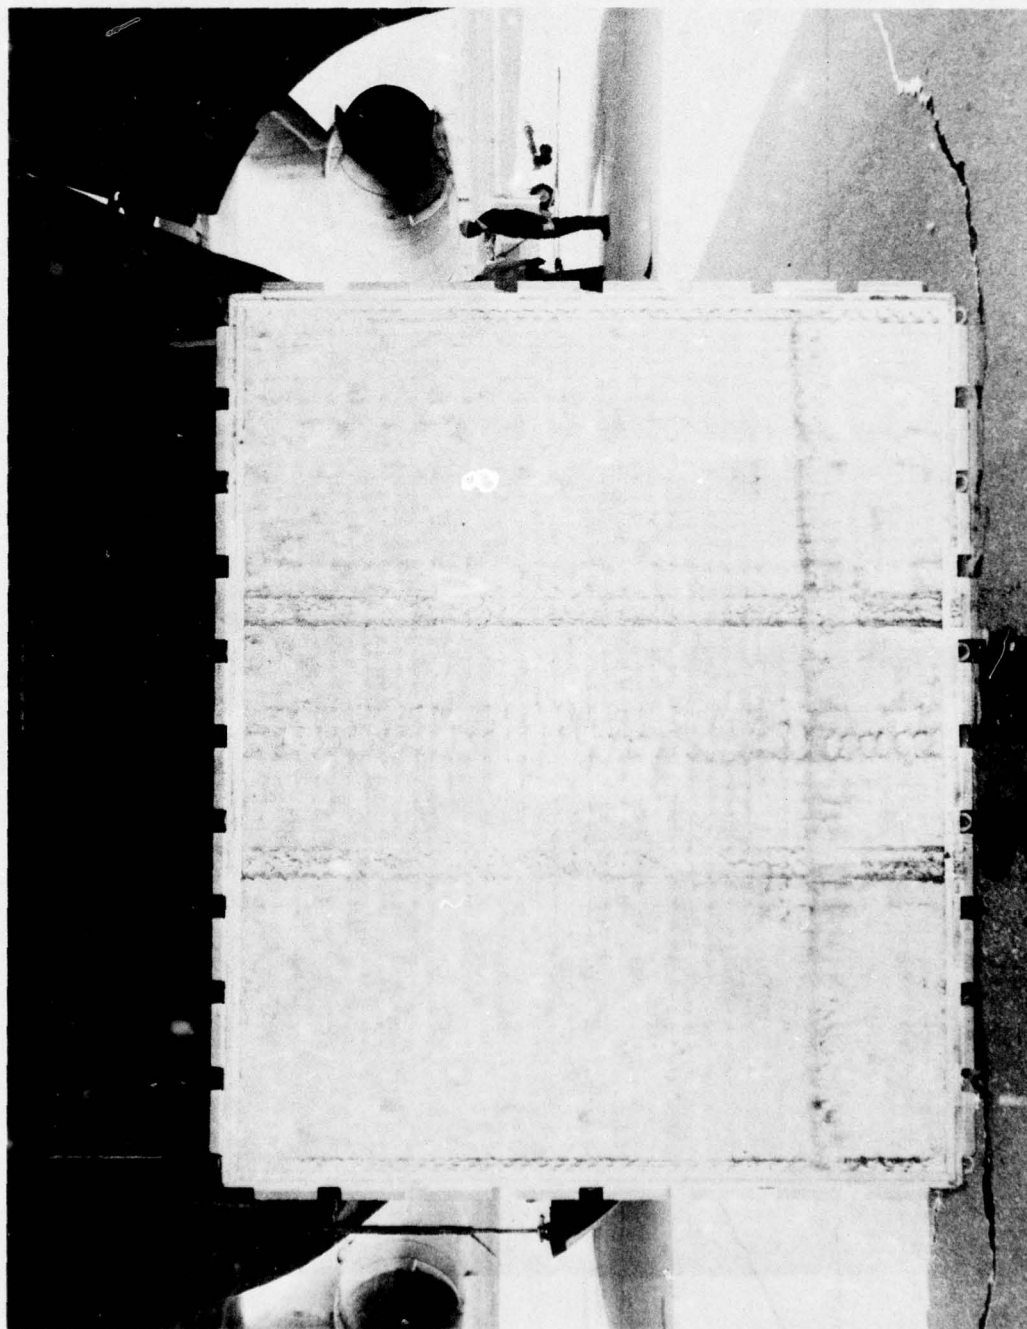
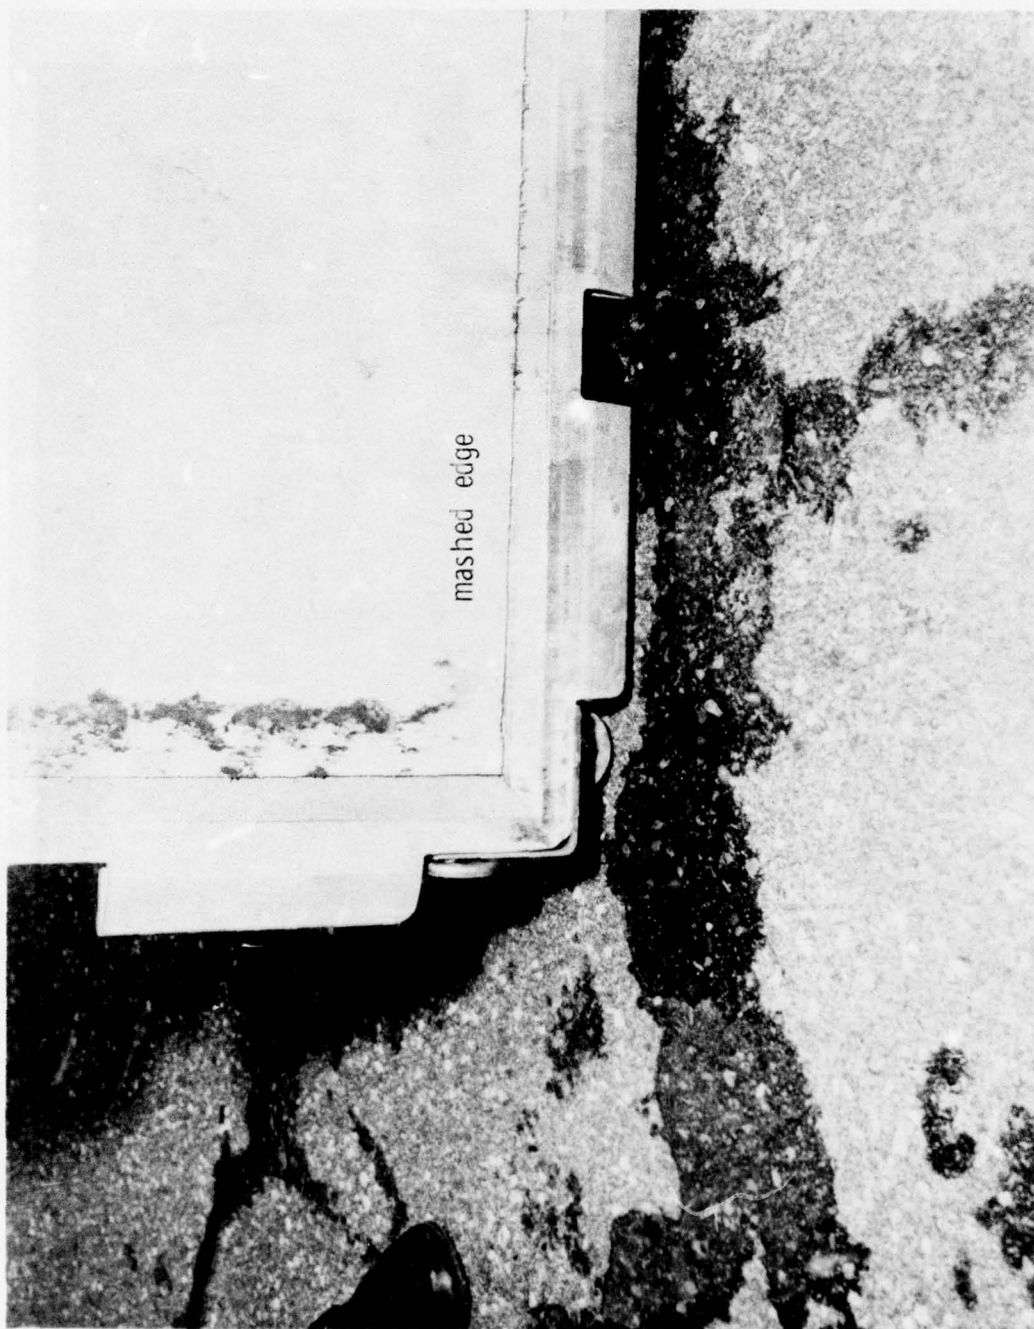
FIGURE 29 - ROLLER CONVEYOR TEST - SIDE IN CONTACT WITH ROLLERS

(1) The HCU-54/E pallet traversed 10,000 feet of roller conveyor with no major damage, as shown in Figure 29. Minor damage in the form of a "mashed" edge, Figure 30, was evident in the location where the rollers cross the pallet. This damage was apparently due to a non coplanar low area between the edge of the polymer center and the inner edge of the side rail. (Section detail is shown in Figure 31.) The side rail low area is utilized for smooth lap joint construction in the aluminum skin, balsa core pallet construction.

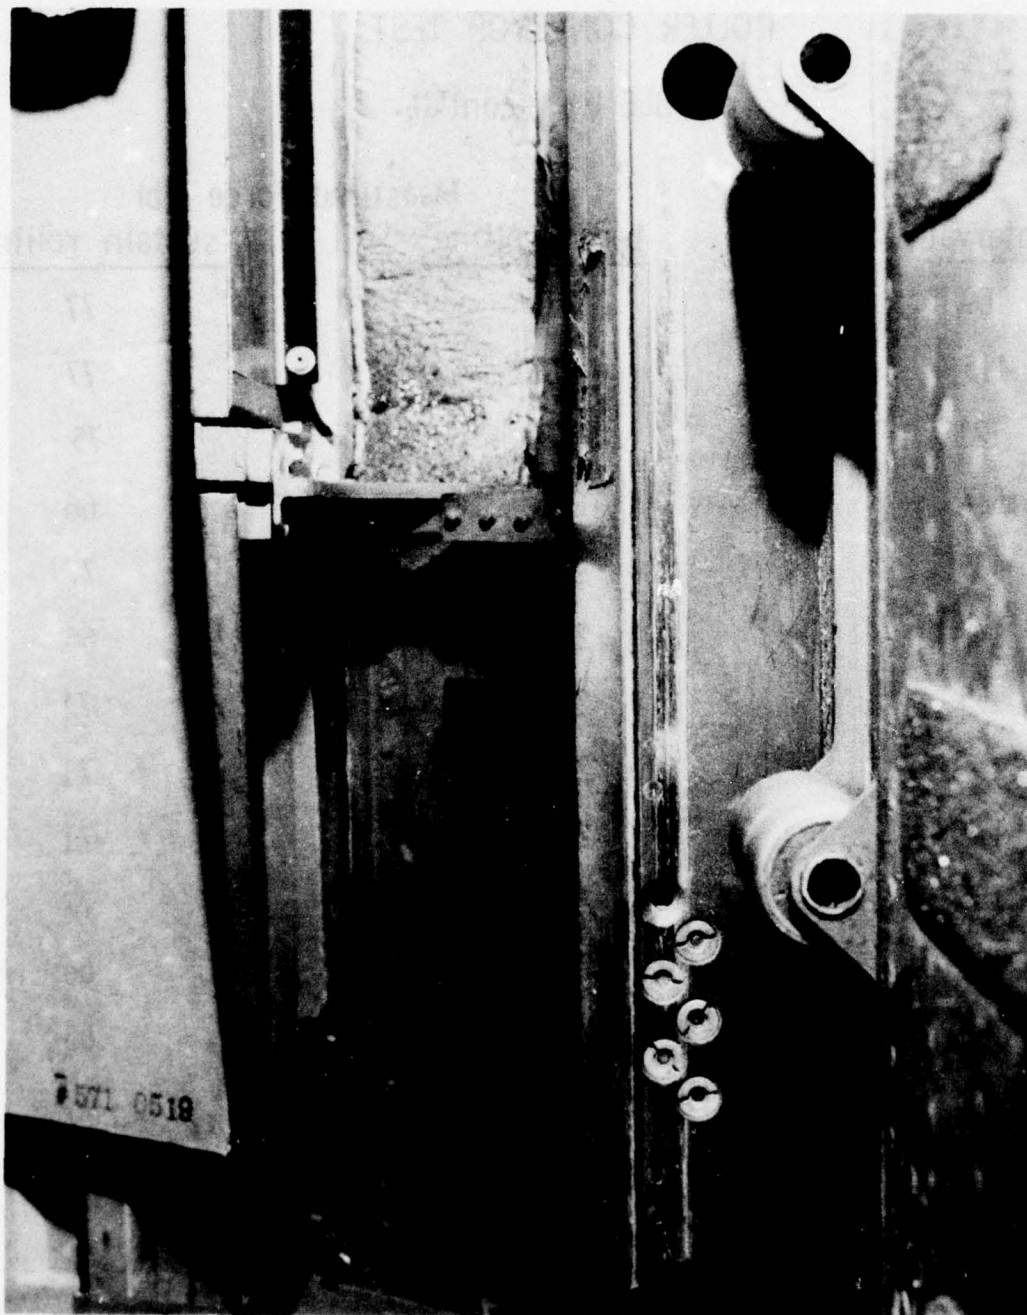
FIGURE 32 - GUIDE RAIL ABRASION

(3) At one particular location in the aircraft, approximately Fus Sta 1140, the pallet came into contact with the guide rails. Scrape and abrasion marks on the guide rail are shown in Figure 32. The damage was determined to be the result of tolerance build-up between the pallet and guide rail.

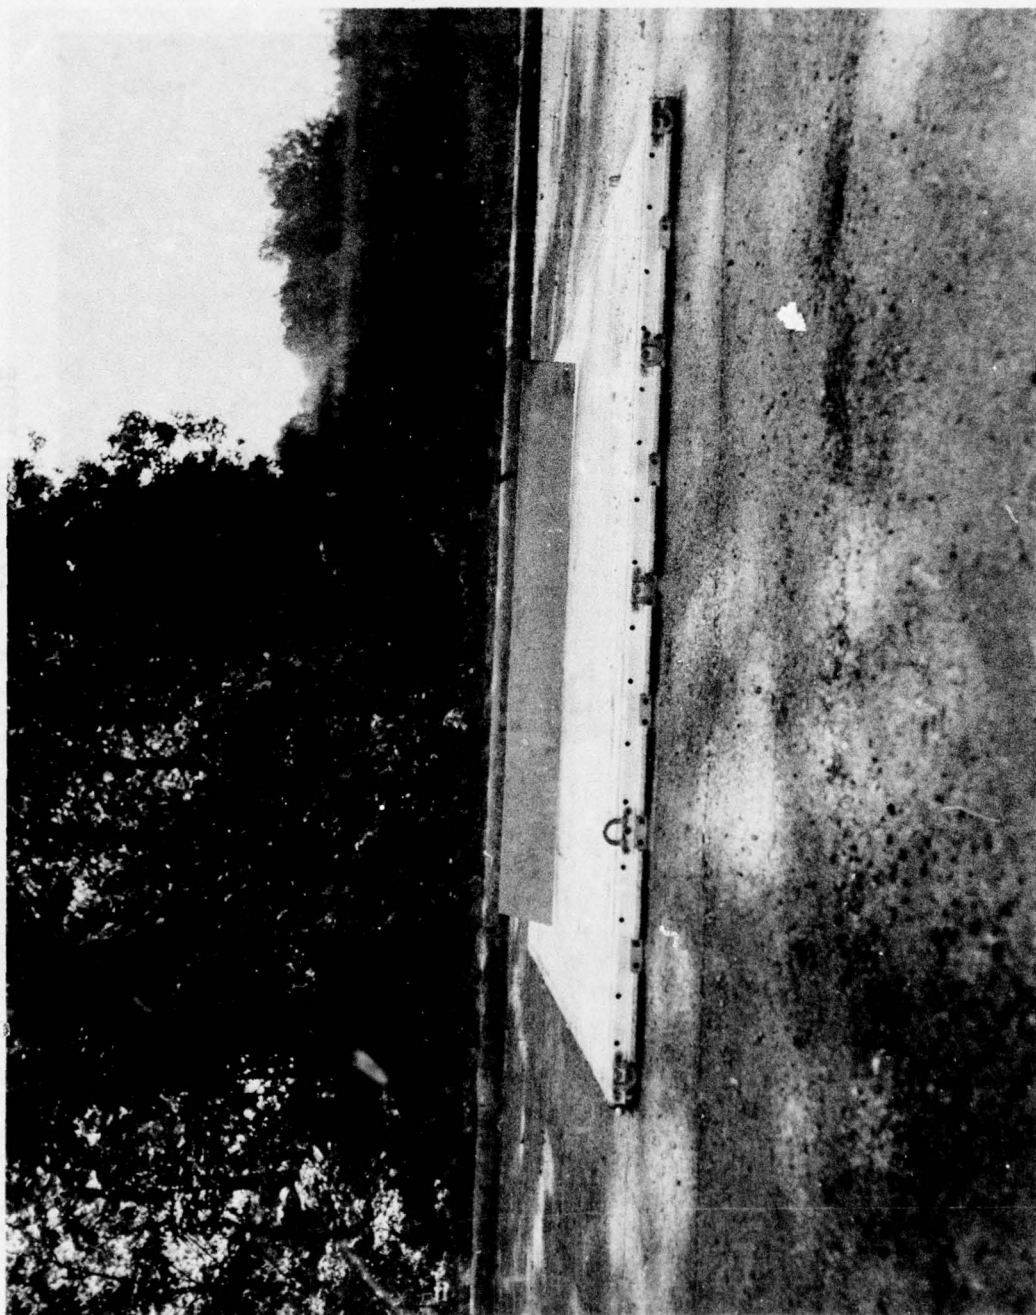
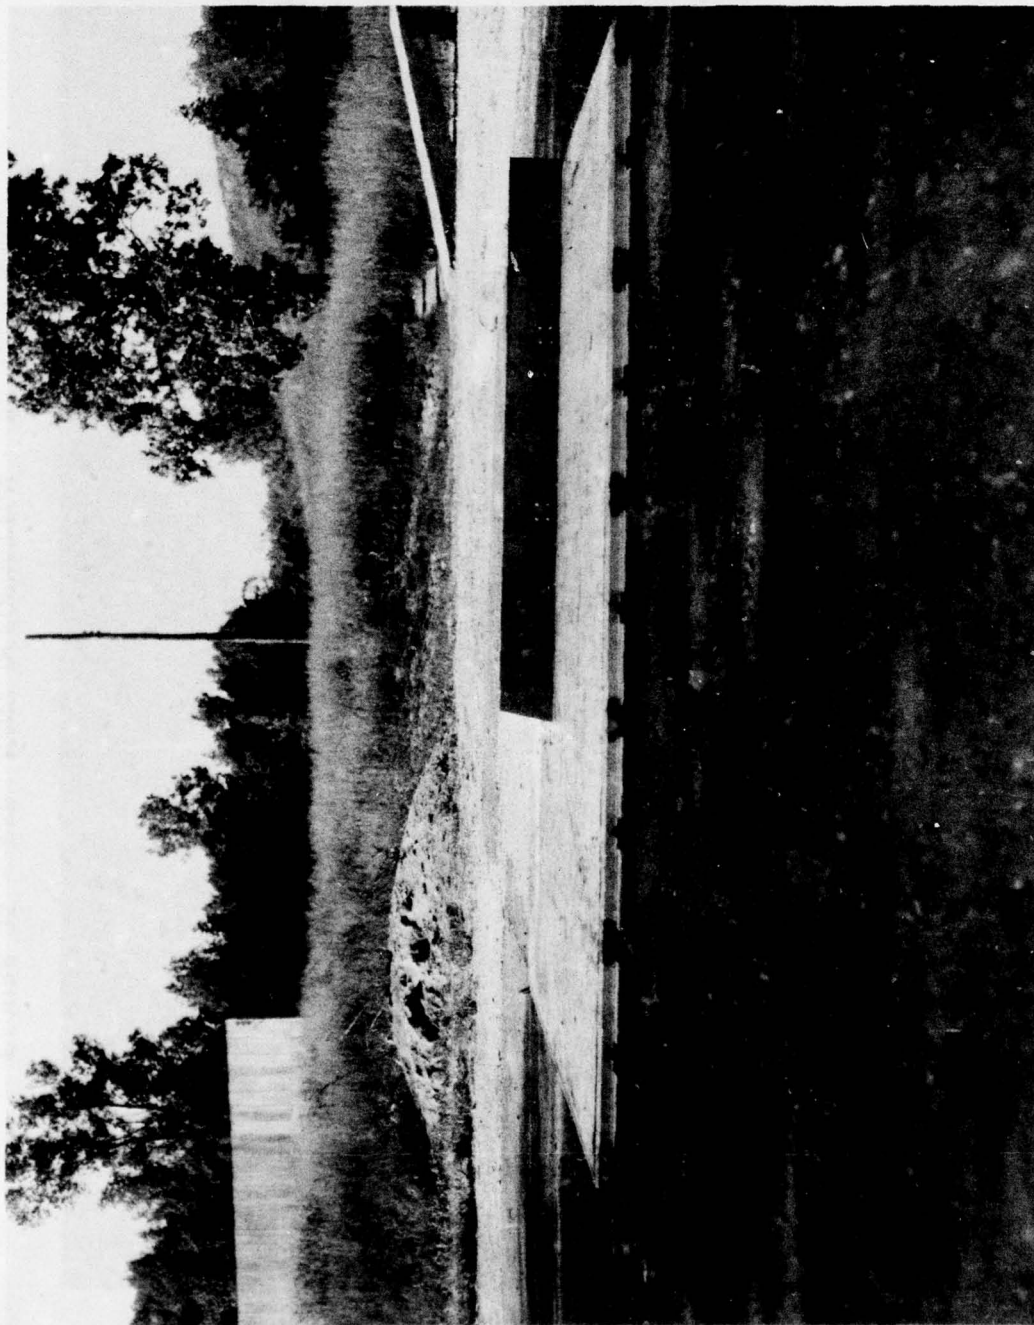
FIGURE 35 - PERMANENT DEFORMATION - 88 INCH EDGE

(2) Permanent deformation was observed and measured after the pallet was unloaded. Figures 35 and 36 illustrate the deflection obtained when viewed from the 88-inch and 108-inch sides, respectively. With the top up, the amount of deflection obtained was 5/8-inch, as shown in Figure 37. The pallet was overturned (bottom up) to measure the depth of the bow from the side rail plane. At approximately the center of the pallet, a 7/8-inch depth was measured, Figures 38, 39, and 40. Since unacceptable deformation was experienced at 6,000 pounds, no 10,000 pound load was accomplished.

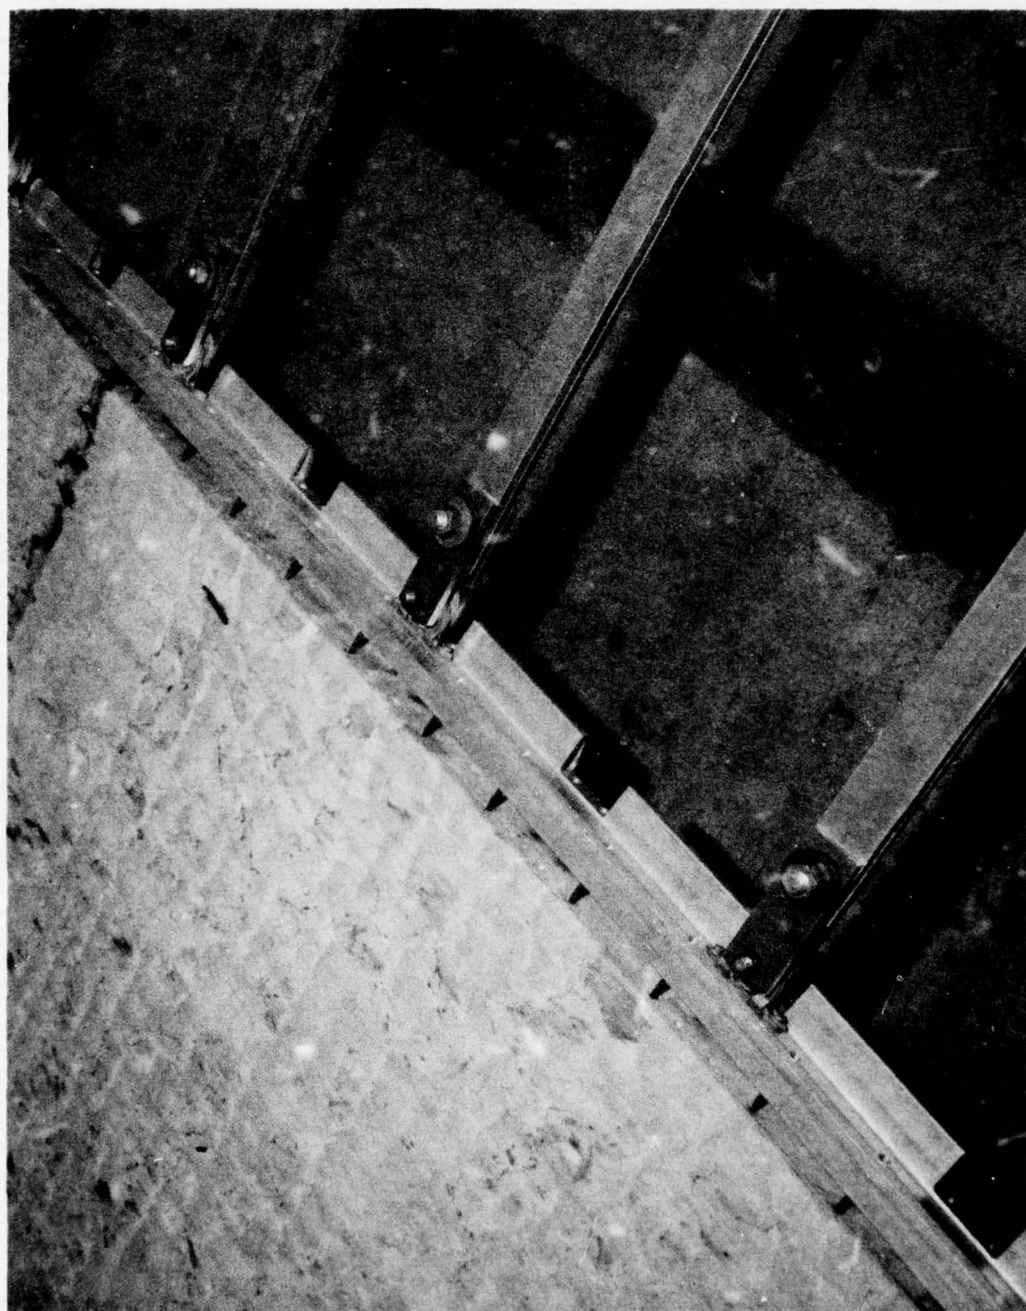
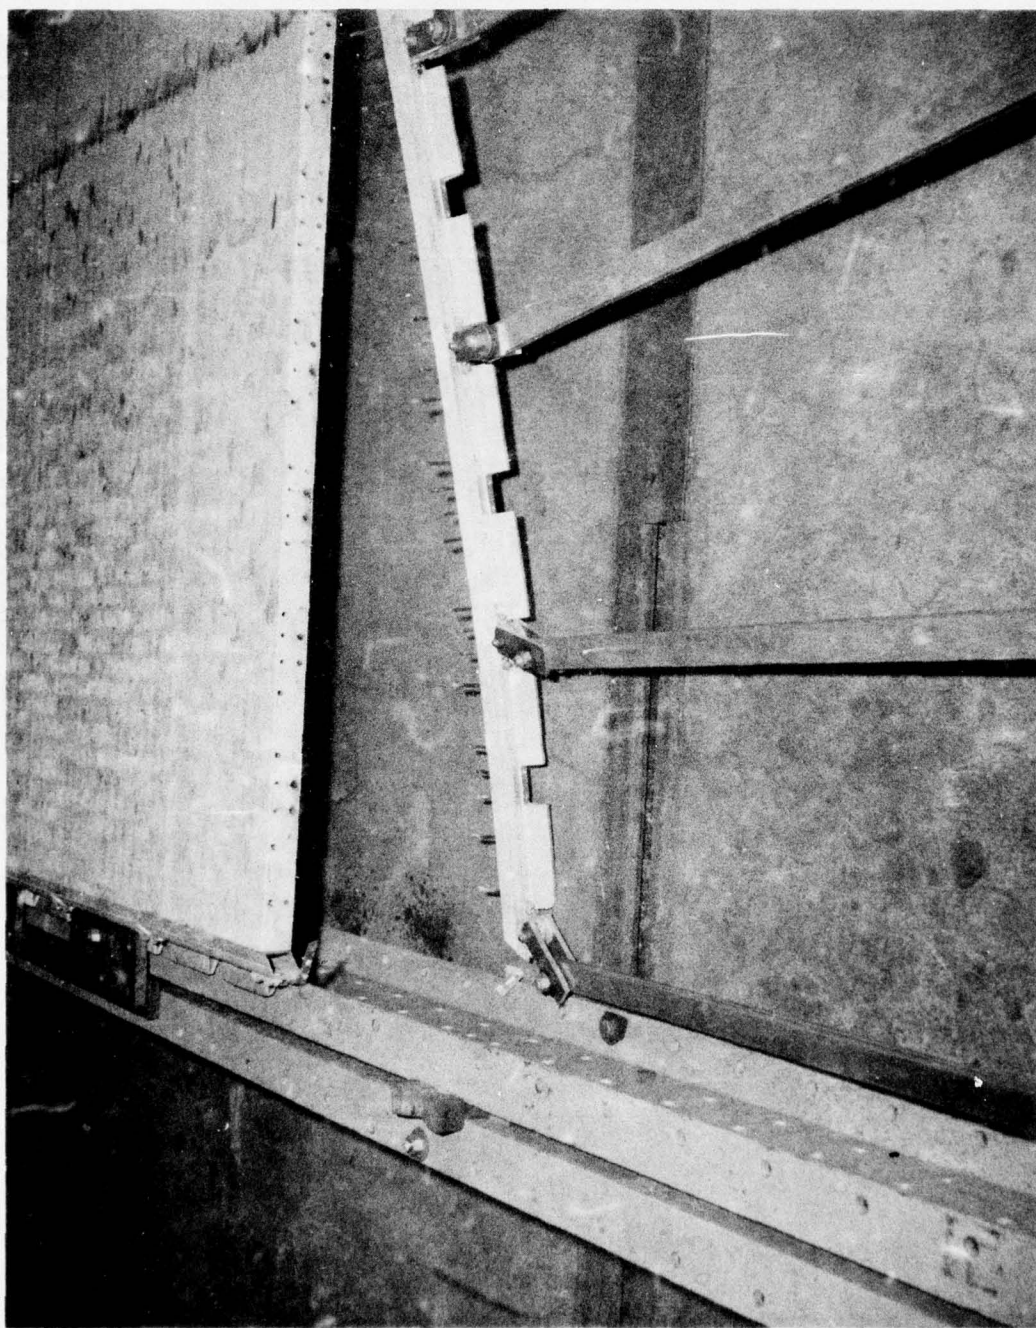
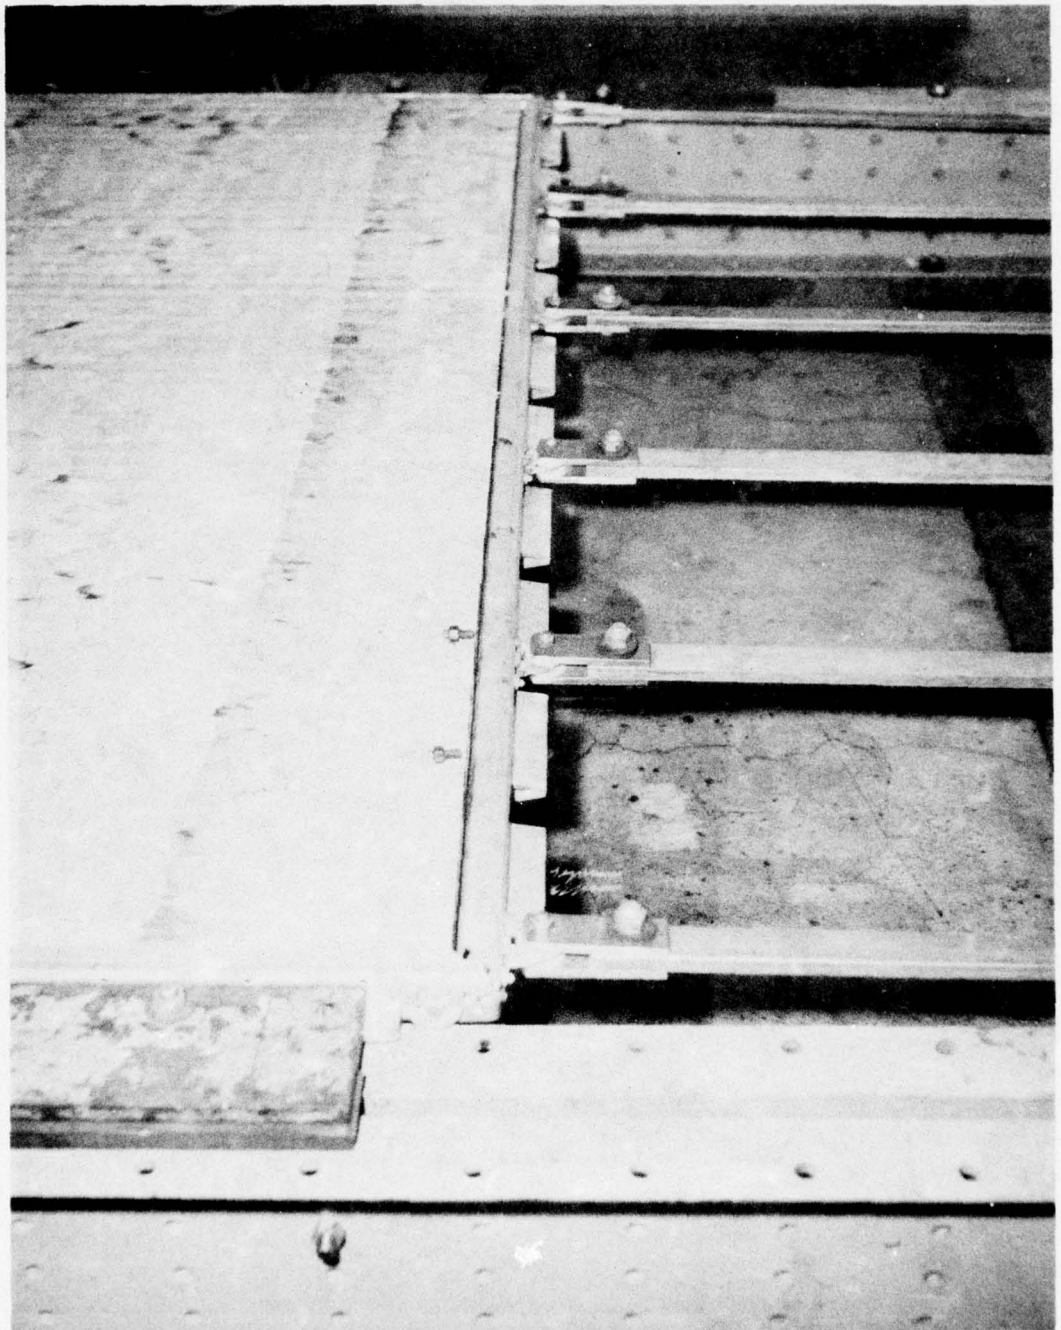
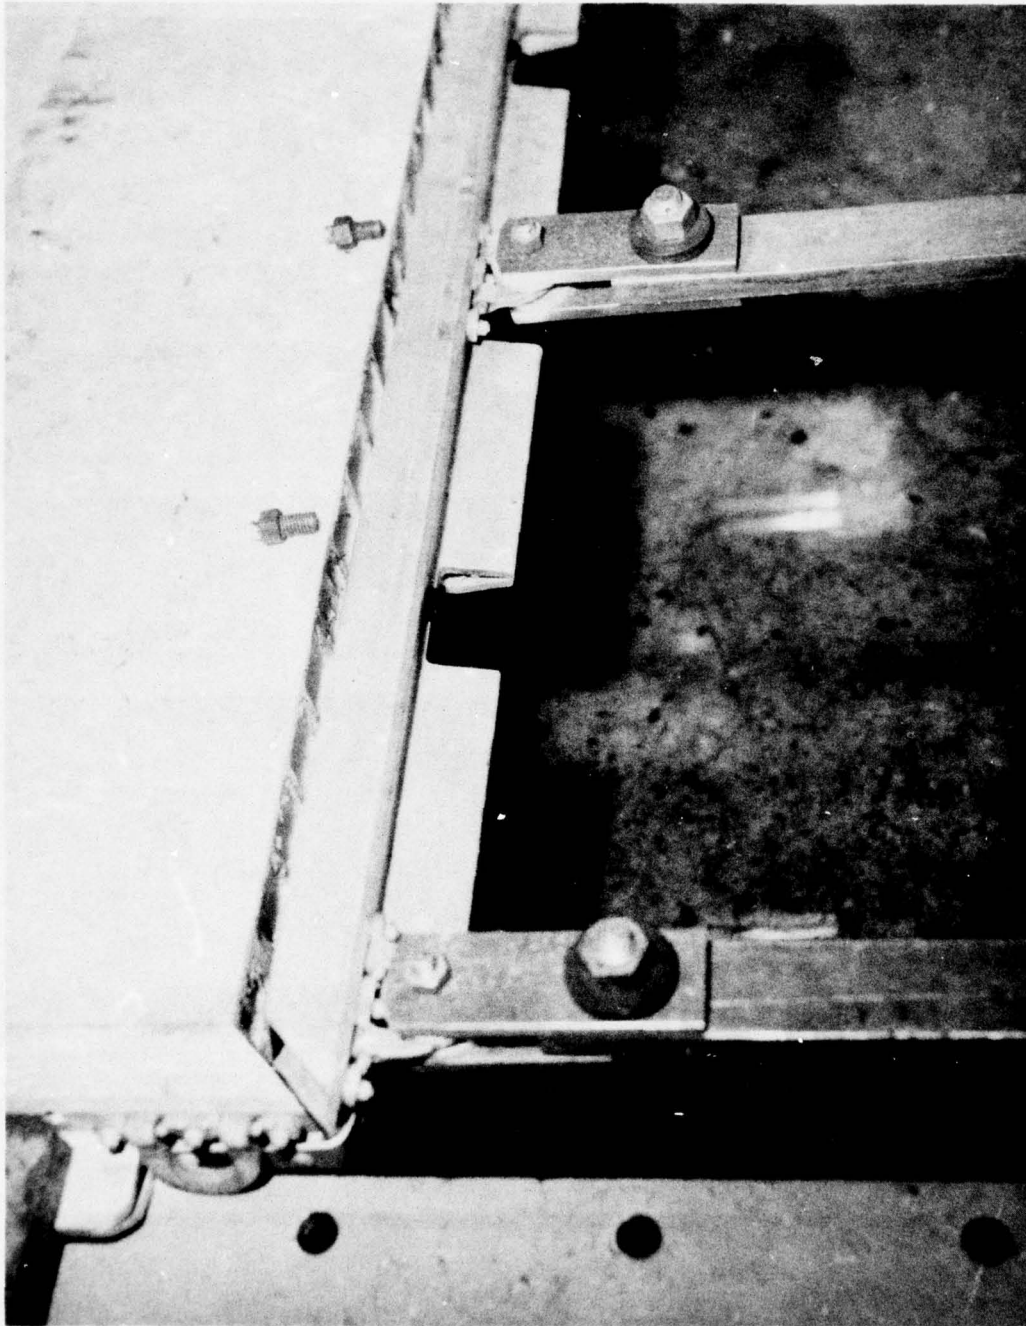
(2) The steel bolts pulled through the aluminum plate located in the second polymer extrusion cavity during the horizontal 88-inch side loading, Figures 41 and 42. The aluminum rods failed in tension in the 108-inch configuration as shown in Figures 43 and 44.
